ANALYSIS OF HOT SECTION FAILURES ON GAS TURBINES IN PROCESS PLANT SERVICE

by
Ian Hunter
Senior Engineer
Joe Daleo
Vice-President
Jim Wilson
Technical Director
and
Keith Ellison
Senior Engineer
BWD Turbines Limited
Ancaster, Ontario, Canada

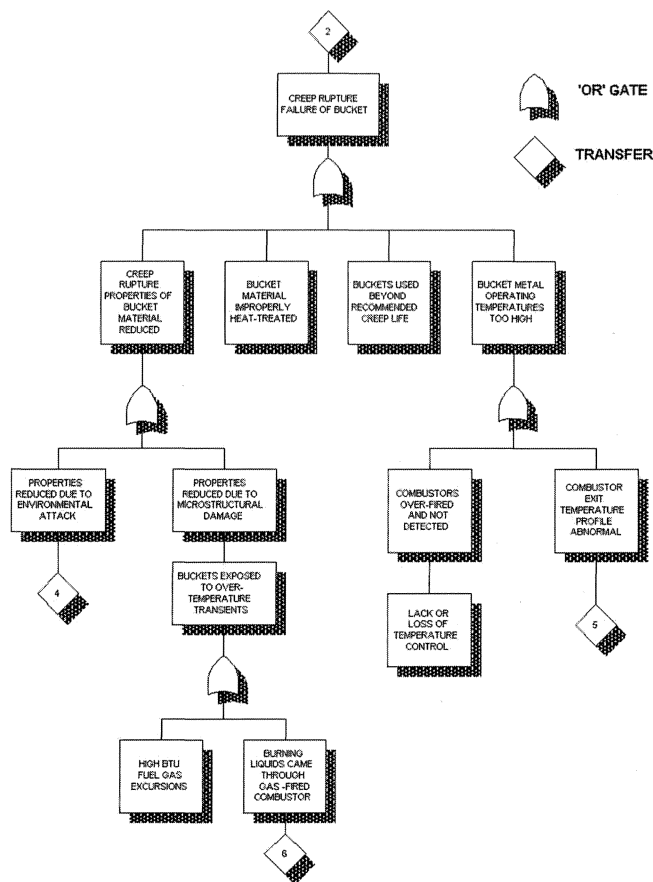
Figure 3. Intermediate Branch of Fault Tree Diagram Used to Analyze the Failure Described in Case History B.

Since fault trees can be quite extensive, only portions can be included in this paper. Parts of two representative diagrams are shown. The diagram, shown in Figure 3, was actually developed following another fault tree put together by the plant investigation team subsequent to a catastrophic turbine failure (Case History B). This first fault tree had been used to help systematically eliminate turbine operational factors, such as instrumentation and control system faults, as causal factors in the failure, thereby narrowing down the range of possibilities to mechanical degradation of components. These issues were then specifically addressed in the second phase of the investigation for which the fault tree here was created. Figure 3 shows an intermediate "branch" of the tree concerned with failure by creep rupture. Other portions of the diagram considered high cycle fatigue, foreign object damage, etc.

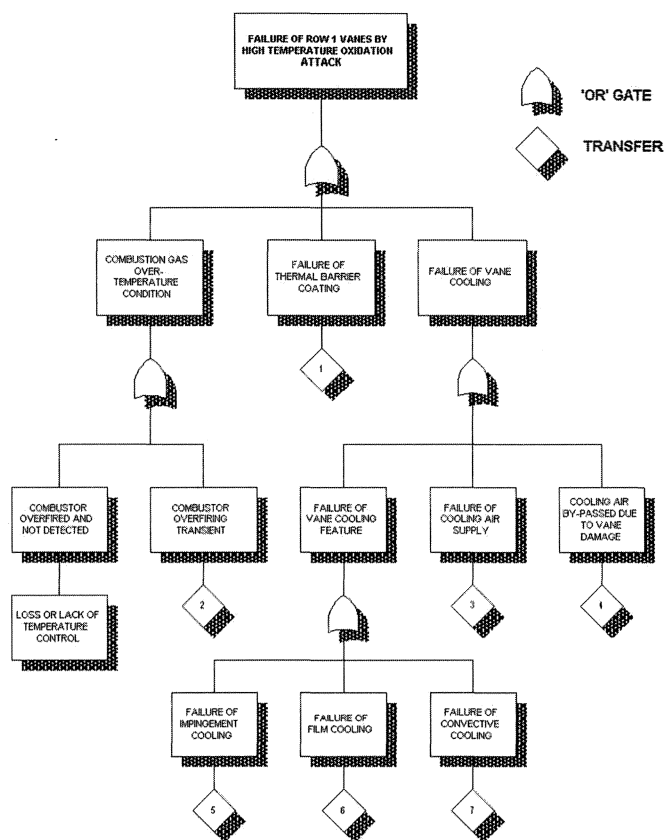
Figure 4. Top Portion of Fault Tree Diagram Used to Analyze the Overheating Failure of Cooled Vanes Described in Case History D.

Figure 4 shows the "top" part of another fault tree. This diagram, prepared for Case History D, explored the potential causes of severe

overheating damage to a row of cooled turbine nozzle vanes. Cause-and-effect chains were developed for exposure of the vanes to excessively high gas temperatures and for failures of the cooling on the vane that comprised impingement, convection, and film features.

As part of the failure analysis, a fault tree was created (Figure 4). Based on the condition of the combustor baskets, transition pieces, first stage rotating blades, and other evidence, it did not appear that the nozzles had been exposed to abnormally high gas temperatures. A cooling failure scenario was more probable, therefore.
